## Pre-Purchase Inspection Report

200 Avenue Street  
Town, QC H1H 1H1

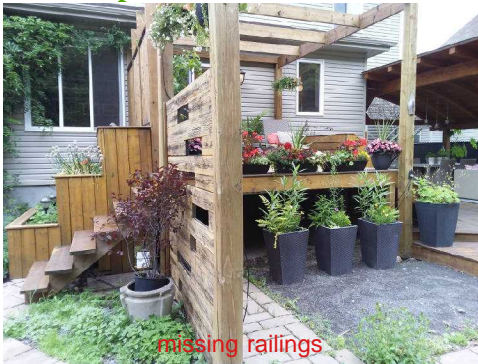
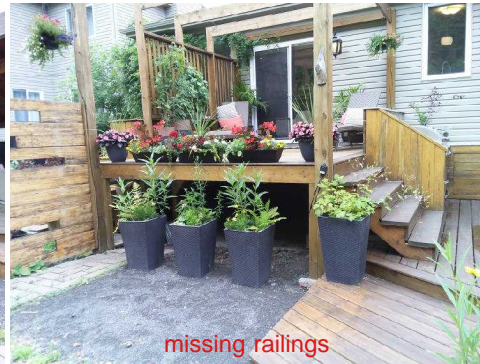
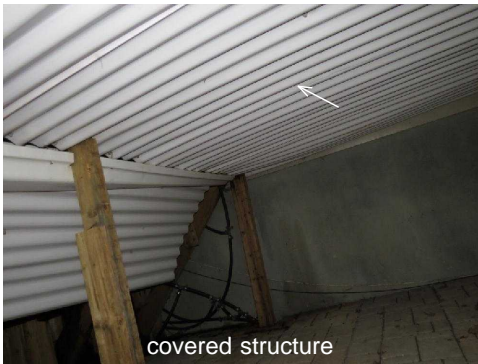
1. Deck: **Wood with steps to grade - Safety railing missing, this is a safety issue that requires immediate correction to prevent personal injuries.**

Deck structure could not be inspected as it was covered up underneath. The inspector could not give an opinion on this component.

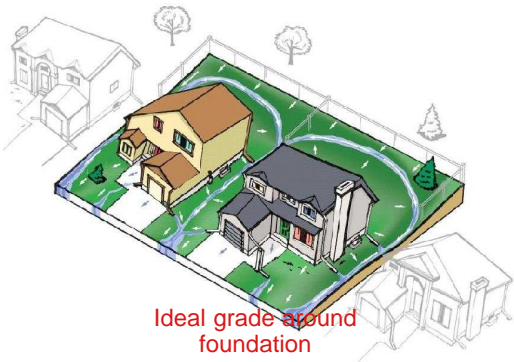
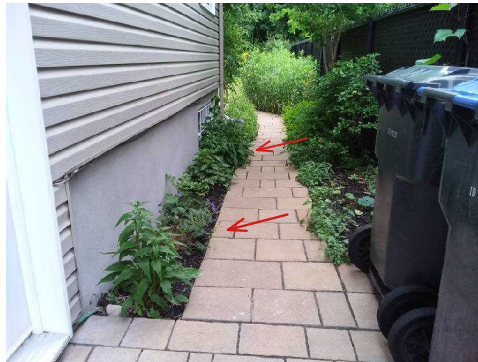
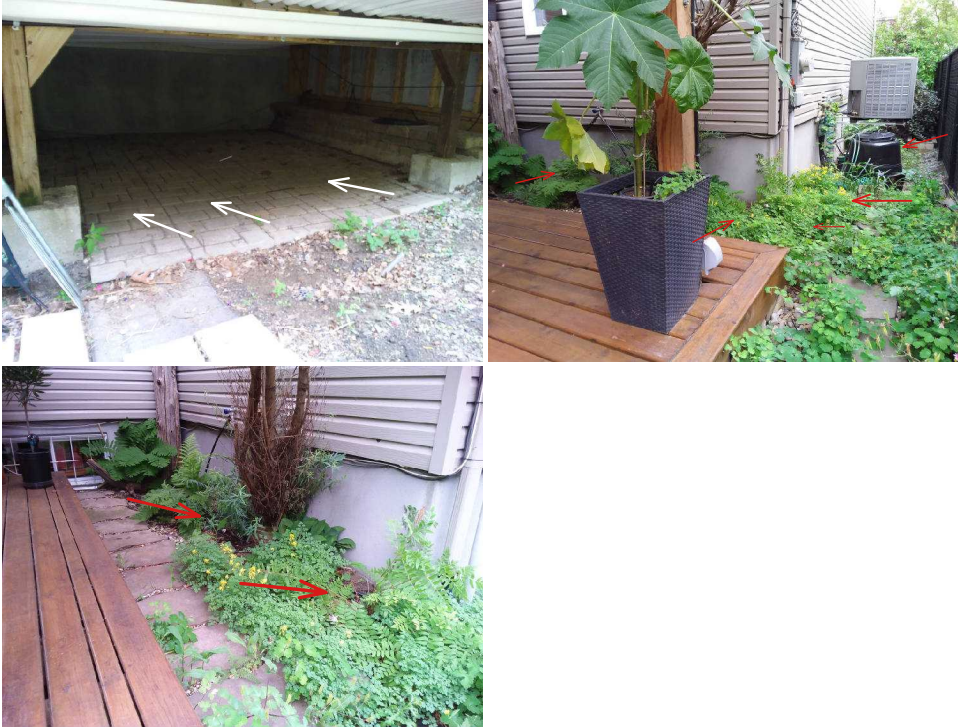
2. Grading: **Negative slope observed - Negative grade slope noted on the Left, Right sides and rear. Immediate build up of positive grade slope (1 inch per foot for 6' from the foundation) is required to divert storm water away from the foundation and prevent water infiltration and damage to basement area.**

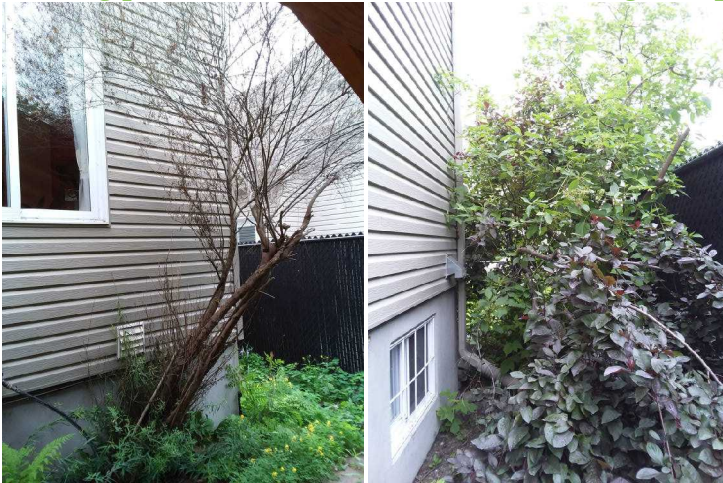
3. Vegetation: **Trees, Hedges** - Trees planted too close to structure rubbing against exterior finished walls causing premature wear. Removal / trimming is required.

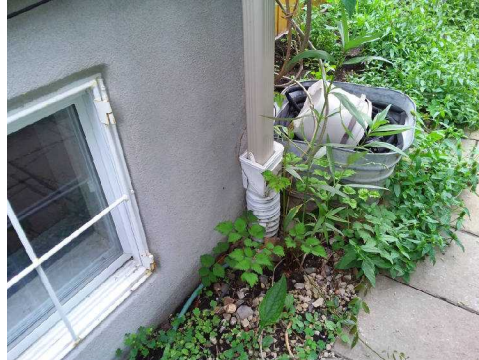
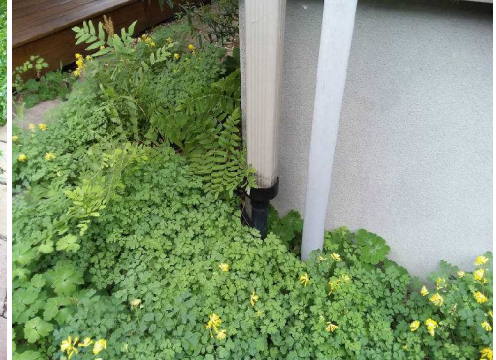
4. Downspouts: **Metal** - Under ground extension pipes noted. The under ground sections are prone to freeze and block the drainage and causing gutters to overflow. Recommend installing above ground extensions as shown on the attached illustration.

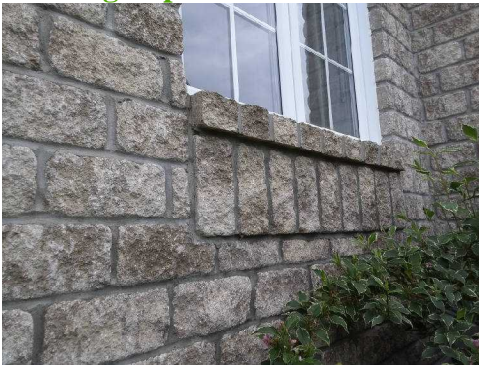
5. Window Sills: **Brick** - Brick sills are prone to leak and damage. Recommend covering with a metal clad / flashing to prevent water infiltration and damage to framing wood.

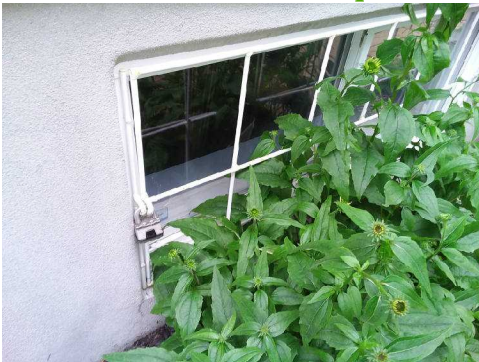
6. Basement Windows: **Vinyl sliding type**. Burglar bars are locked which restrict exits in case of emergency. Immediate removal is required to allow for safe emergency escape.

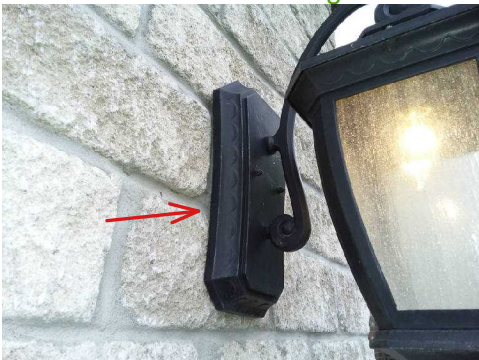
7. Exterior Lighting: **Surface mount** - Light bases not caulked (weather proofed). Caulking required to prevent water infiltration & damage to wood structure behind.

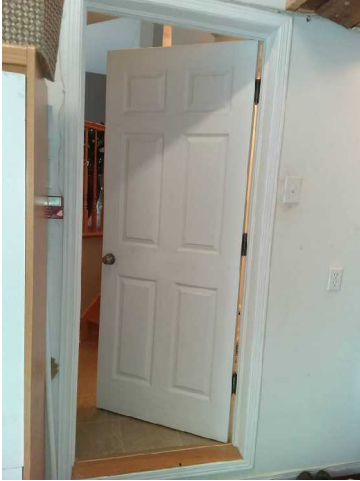
8. : Attached Garage Service Doors: **Fire rated, Wood - Self closing mechanism not functioning properly.**  
**Repairs / adjustment required.**

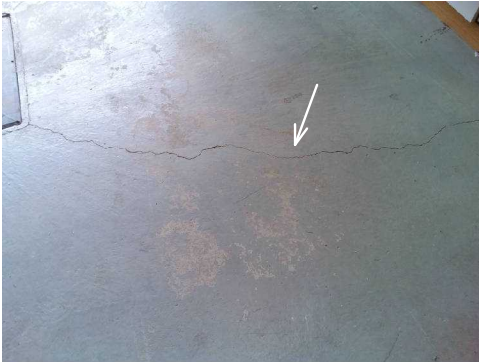
9. : Attached Garage Floor: **Poured concrete - Typical shrinkage cracks observed. Future monitoring required and repair as needed.**

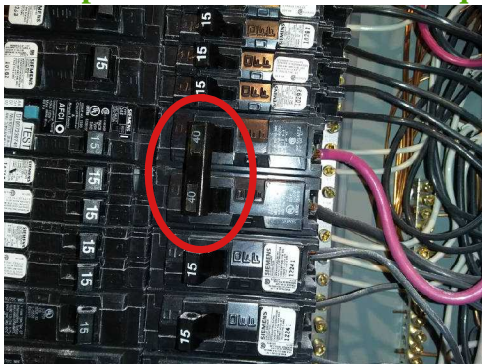
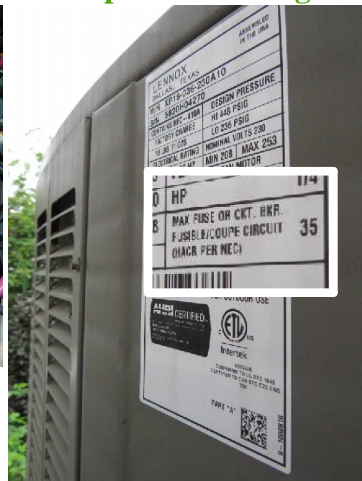
10. 240 VAC Branch Circuits: **Copper - AC or heat pump breaker must be 35 amp max. The one installed is 40 amp. Immediate correction required to prevent damage to the unit.**

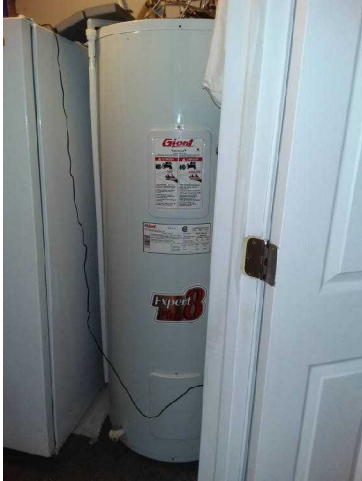
11. : Basement Water Heater Water Heater Operation: **To be replaced - The 11 year old water heater is functional at the time of inspection but at the end of its useful life. Immediate replacement required to prevent failure & water damage.**

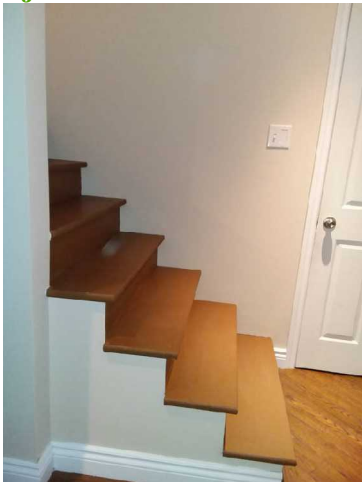
12. : Playroom Living Space Basement Stairs/Railings: **Wood stairs - Missing guardrail and hand railing for fall protection safety. This is a safety concern that needs immediate correction to prevent personal injuries.**

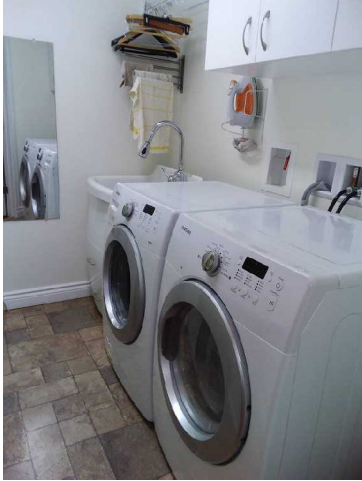
13. : Basement Laundry Room/Area HVAC Source: **None installed** - **No permanent heating installed in the bathroom. Recommend installing an electric baseboard heater to prevent water pipes from freezing..**

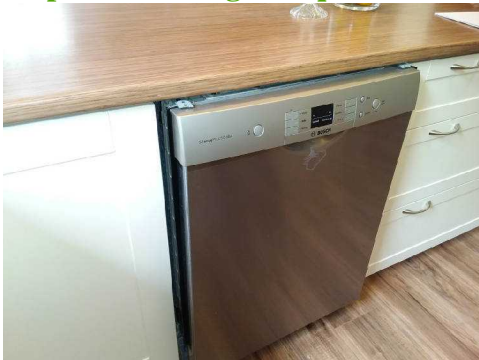
14. : Ground Floor Kitchen Dishwasher: **Loose** - **Dish washer not properly secured to counter/base cabinets. Proper anchoring is required.**

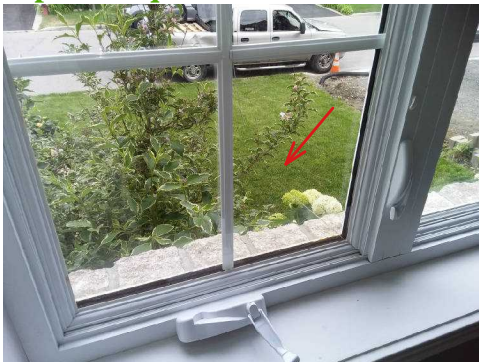
15. : Entrance / Hallway / Living Room Area Living Space Windows: **Vinyl casement** - **Cracked glass noted, Repairs required.**

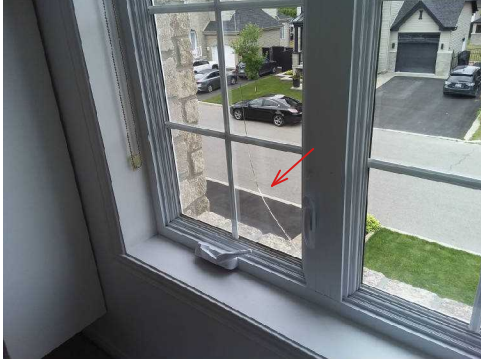
16. : 2nd Floor bedroom 2 Bedroom Windows: **Vinyl casement - Cracked glass noted, Repairs required.**

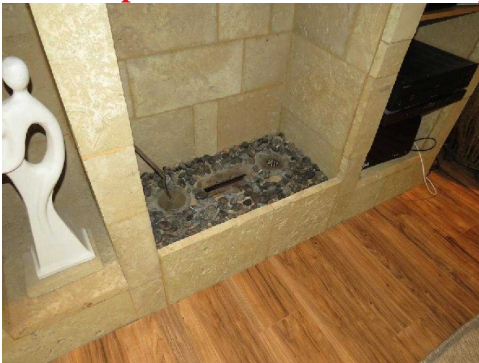
1. Fire Place & Flue: **Beyond scope of this inspection. Inspecting the fireplace and flue is beyond the scope of this inspection.**

**The fire place and flue must be inspected and certified by a master sweep prior to closing.**

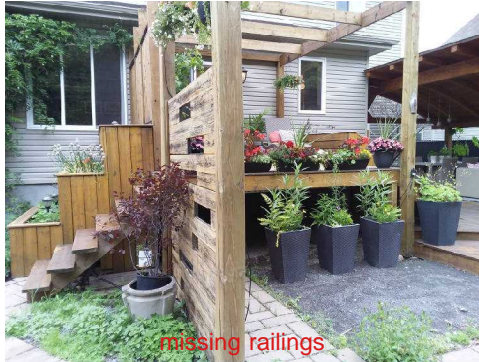
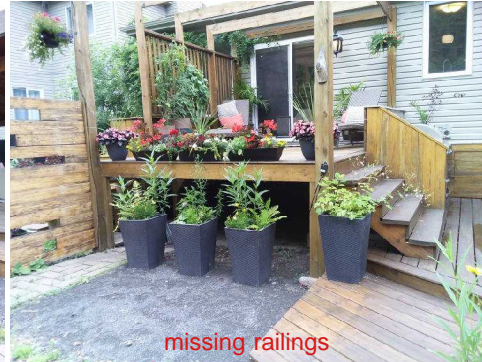
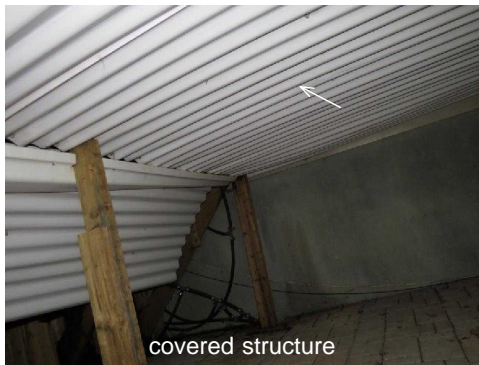
### 5. Marginal

Deck: **Wood with steps to grade** - Safety railing missing, this is a safety issue that requires immediate correction to prevent personal injuries.

Deck structure could no be inspected as it was covered up underneath. The inspector could not give an opinion on this component.

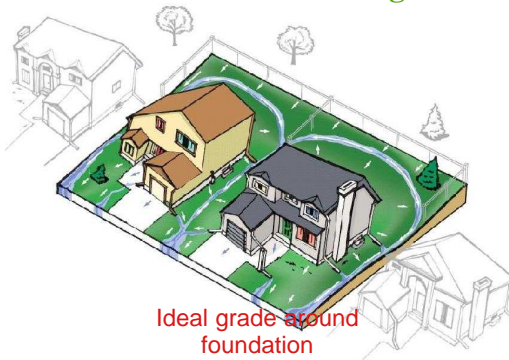
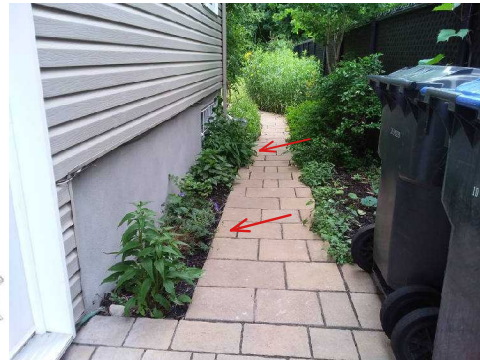
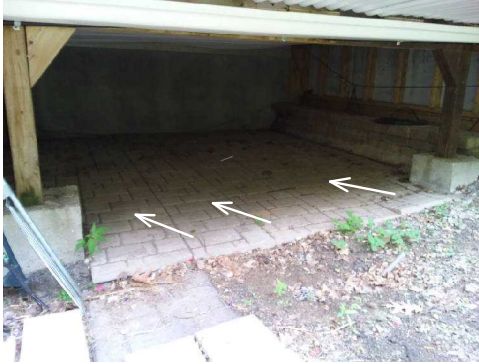
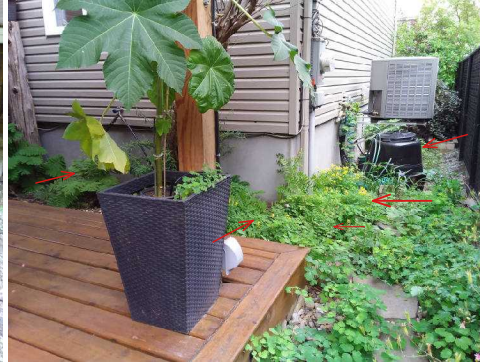
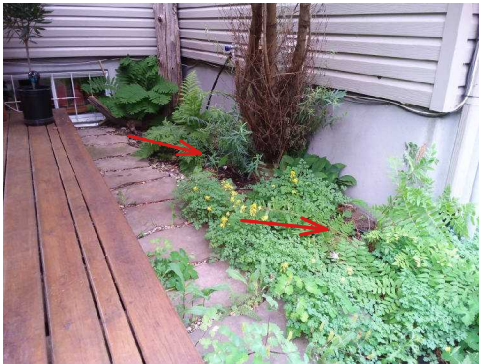
### 6. Marginal

Grading: **Negative slope observed** - Negative grade slope noted on the Left, Right sides and rear. Immediate build up of positive grade slope (1 inch per foot for 6' from the foundation) is required to divert storm water away from the foundation and prevent water infiltration and damage to basement area.

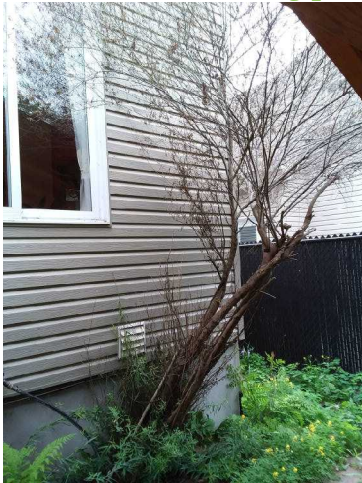
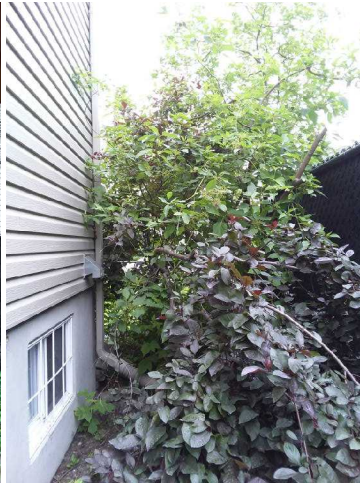
### 7. Marginal

Vegetation: **Trees, Hedges** - Trees planted too close to structure rubbing against exterior finished walls causing premature wear. Removal / trimming is required.

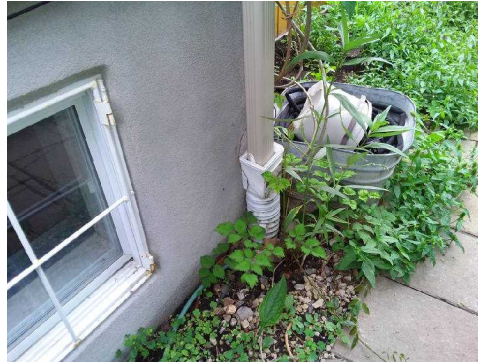
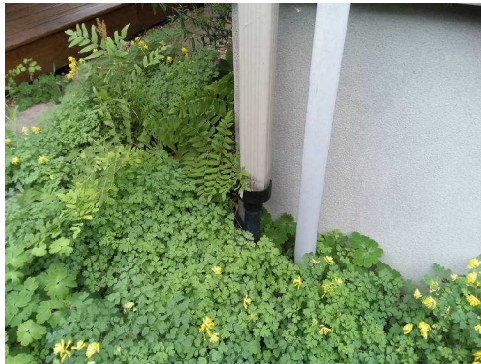
Downspouts: **Metal - Under ground extension pipes noted. The under ground sections are prone to freeze and block the drainage and causing gutters to overflow. Recommend installing above ground extensions as shown on the attached illustration.**

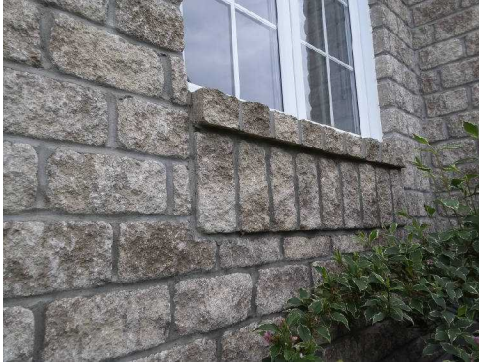
Window Sills: **Brick** - Brick sills are prone to leak and damage. Recommend covering with a metal clad / flashing to prevent water infiltration and damage to framing wood.

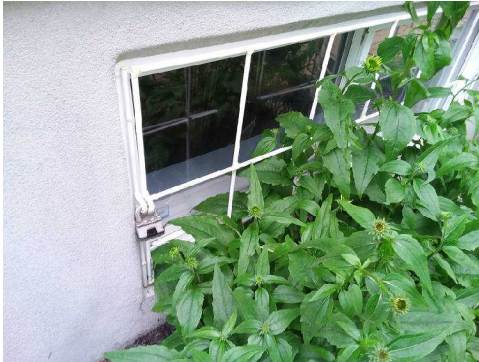
10. **Marginal**

Basement Windows: **Vinyl sliding type**. Burglar bars are locked which restrict exits in case of emergency. Immediate removal is required to allow for safe emergency escape.

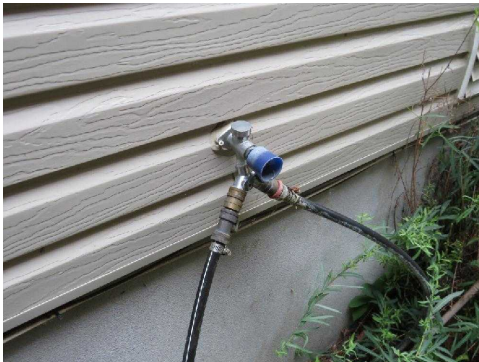
Hose Bibs: Frost resistant (self draining type) - Do not leave garden hoses connected to hose bibs when freezing temperatures are possible. Damage to the valve or piping could result.

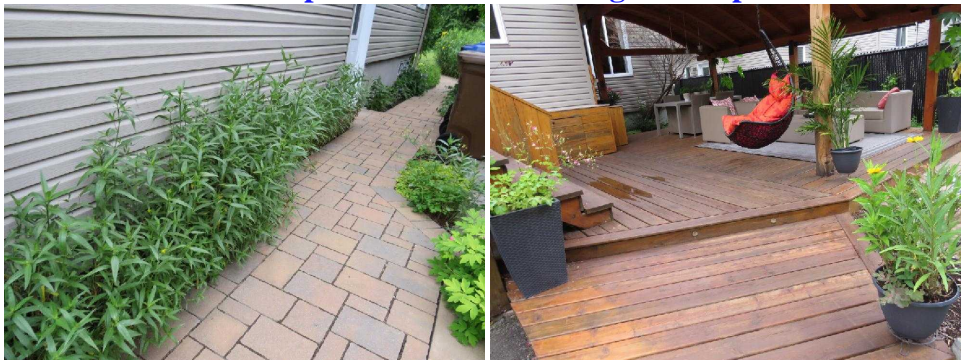
**Patio -** Portions of the exterior foundation covered by rear patio / deck. Inspector was unable to view that area at the time of inspection and could not give an opinion on the component.

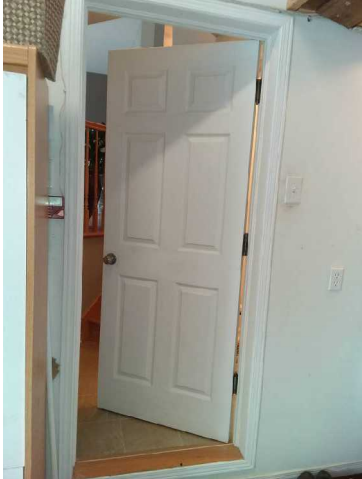
Service Doors: **Fire rated, Wood** - Self closing mechanism not functioning properly.  
**Repairs / adjustment required.**

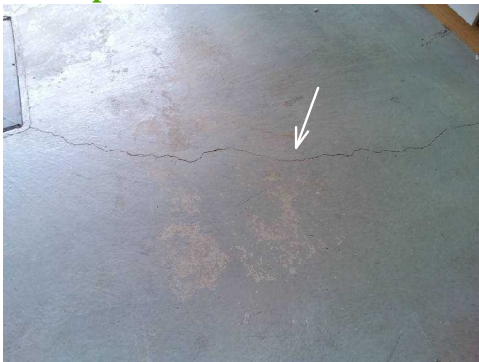
11. Marginal

Floor: **Poured concrete** - Typical shrinkage cracks observed. Future monitoring required and repair as needed.

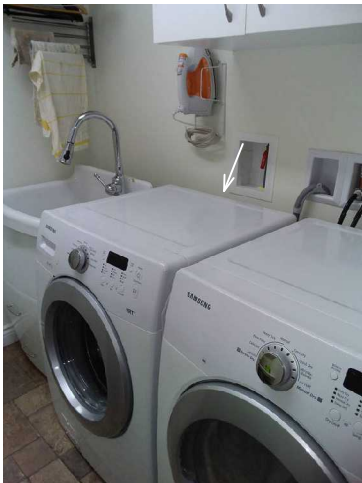
1. **Not Inspected** Service Line: Service pipe was covered with finished walls behind the washer. Inspector could not give an opinion on this component. It is recommended the client obtain such information from the seller.

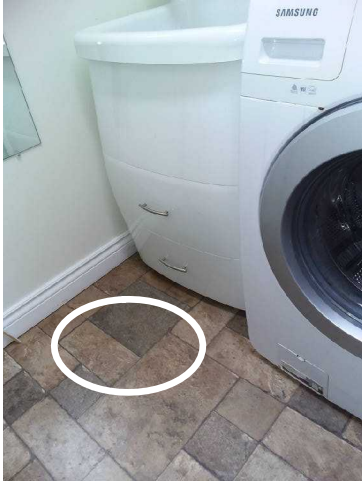
8. **Not Inspected** Sump Pump & Pit: **Submerged** - The seller claimed in the presence of the buyer, buyer's broker and seller's broker of an electric sump pump installed under the finished floors in the basement Laundry. The inspector couldn't verify the presence nor the operation of this component as it was not accessible.

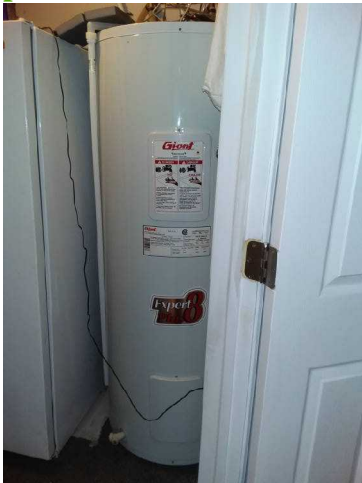
10. **Marginal** Water Heater Operation: **To be replaced - The 11 year old water heater is functional at the time of inspection but at the end of its useful life. Immediate replacement required to prevent failure & water damage.**

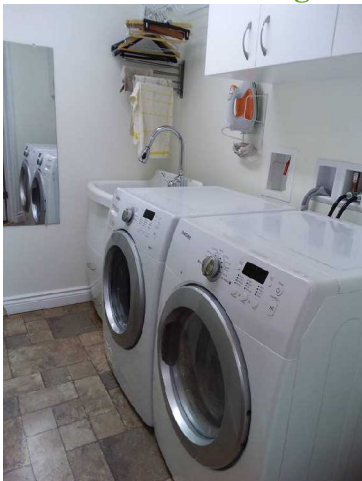
Recommend installing an electric baseboard heater to prevent water pipes from freezing..

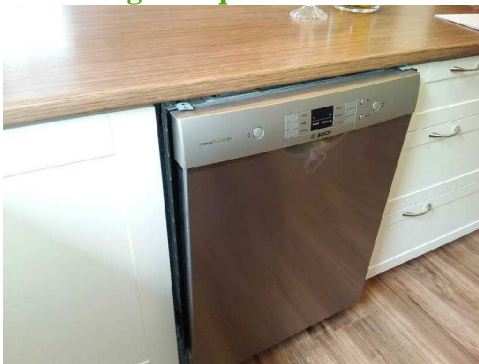
1. **Not Inspected** Cooking Appliances: **Appliance inspections are not part this inspection per the standard of practice.**
2. **Acceptable** Ventilator: **Electric Fan Hood**
3. **Marginal** Dishwasher: **Loose - Dish washer not properly secured to counter/base cabinets. Proper anchoring is required.**

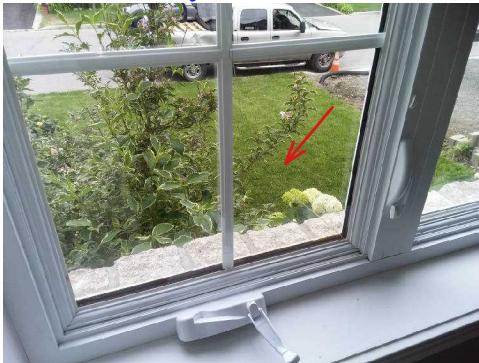
Windows: **Vinyl casement - Cracked glass noted, Repairs required.**

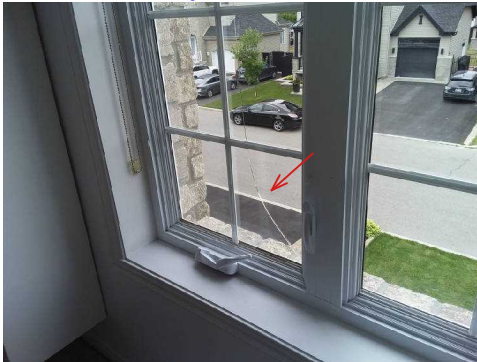
Windows: **Vinyl casement - Cracked glass noted, Repairs required.**
