## Pre-Purchase Inspection Report

200 Avenue Street  
Town, QC H1H 1H1

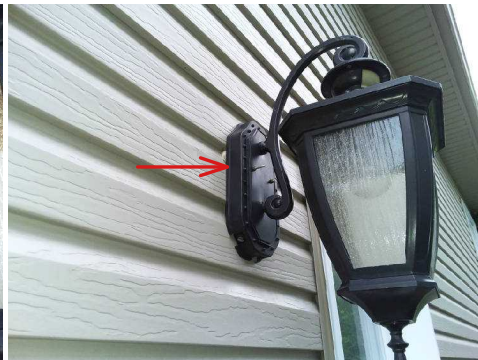
7. Exterior Lighting: **Surface mount** - Light bases not caulked (weather proofed). Caulking required to prevent water infiltration & damage to wood structure behind.

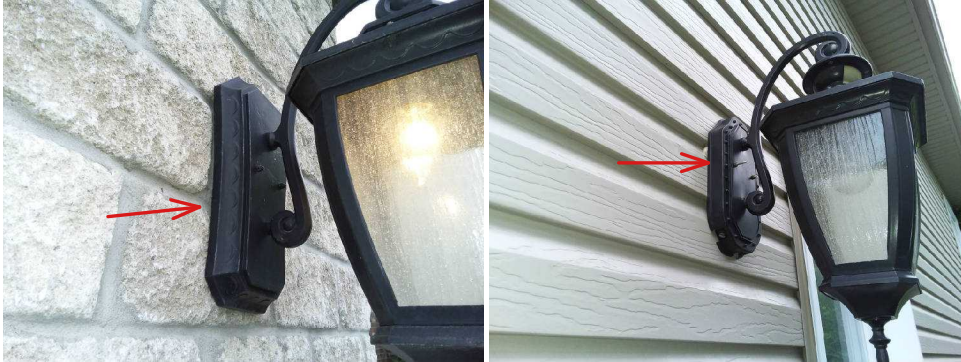
### Exterior Lighting: (continued)

Exterior Lighting: **Surface mount** - Light bases not caulked (weather proofed). Caulking required to prevent water infiltration & damage to wood structure behind.

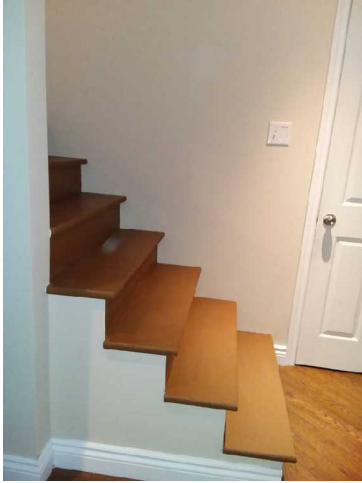
Basement Stairs/Railings: (continued)

Basement Stairs/Railings: **Wood stairs - Missing guardrail and hand railing for fall protection safety. This is a safety concern that needs immediate correction to prevent personal injuries.**

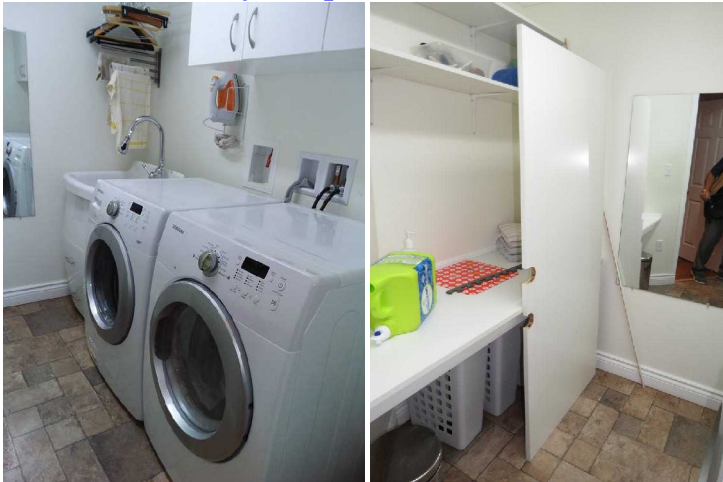
Recommend installing an electric baseboard heater to prevent water pipes from freezing..

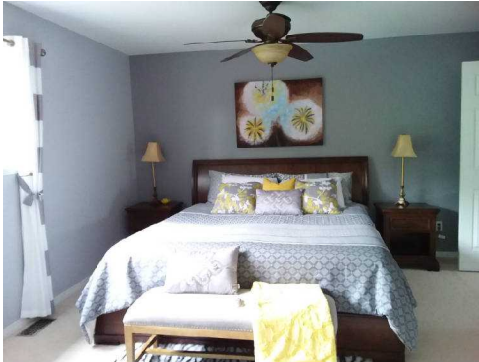
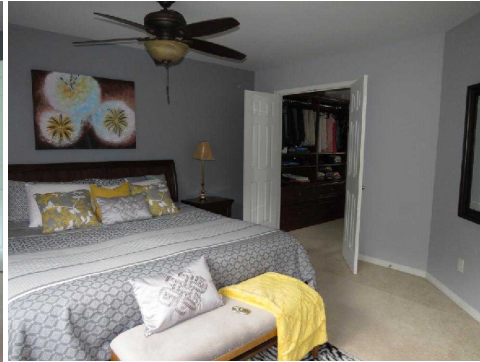
2. **Acceptable** Ceiling: **Painted drywall/plaster.**  
3. **Acceptable** Walls: **Painted drywall/plaster.**

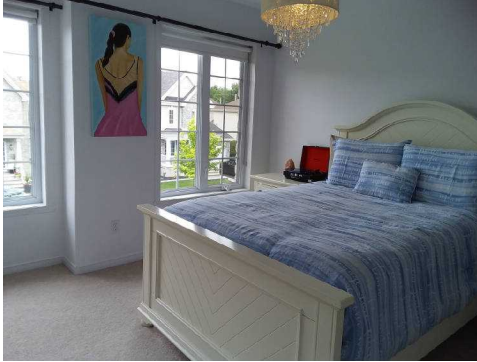
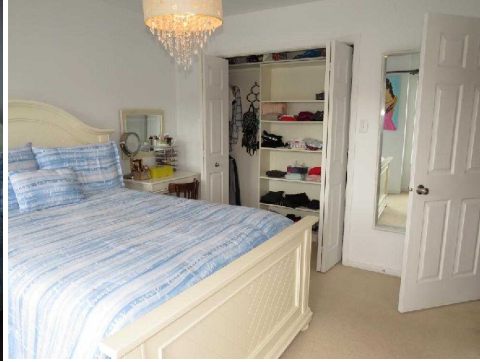
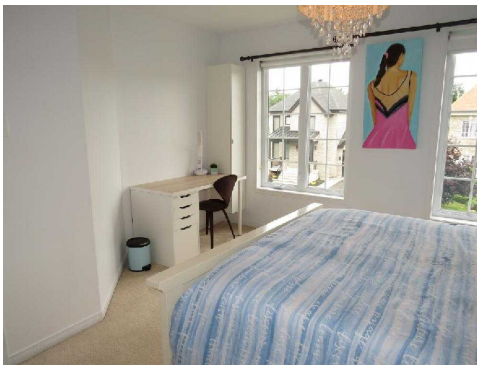
Walls: **Painted drywall/plaster.**

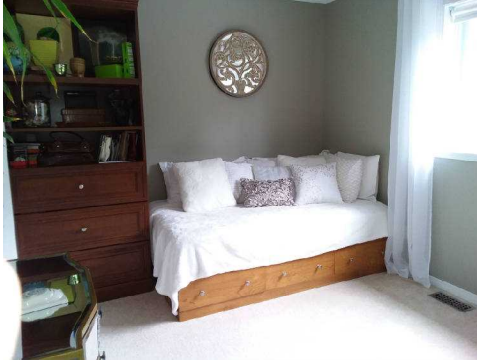
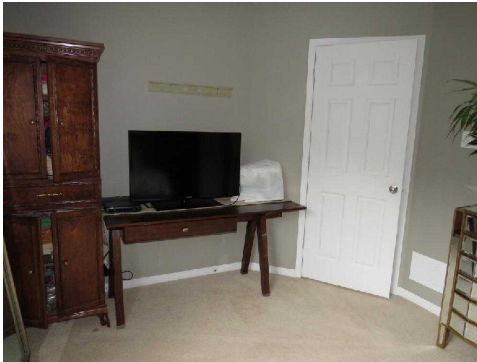
Ceiling: Painted drywall/plaster.

Walls: Painted drywall/plaster.

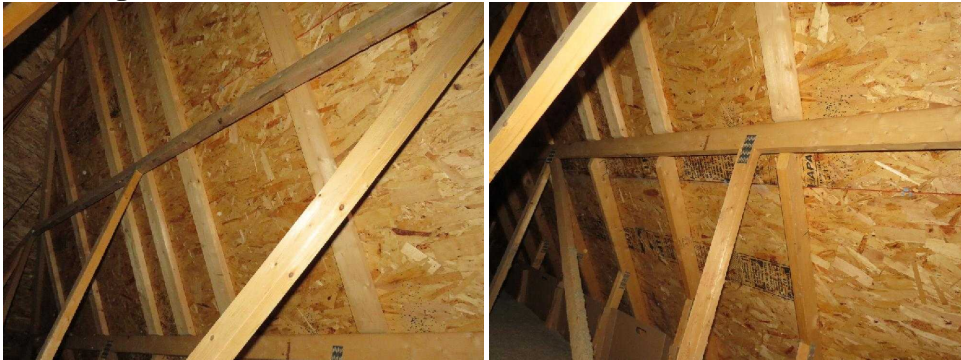
Sheathing: OSB (Oriented Strand Board)

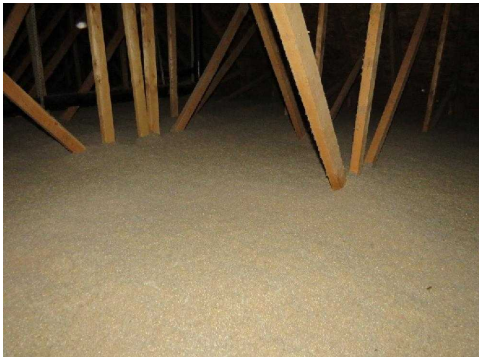
Ventilation: Roof and soffit vents  
Insulation: Blown Cellulose
